Marine Surveying

– It's benefits to
Commercial Shipping &
your Company's bottom line

ICS ME SILVER JUBILEE CPD WEBINAR SERIES

22ND NOVEMBER 2020

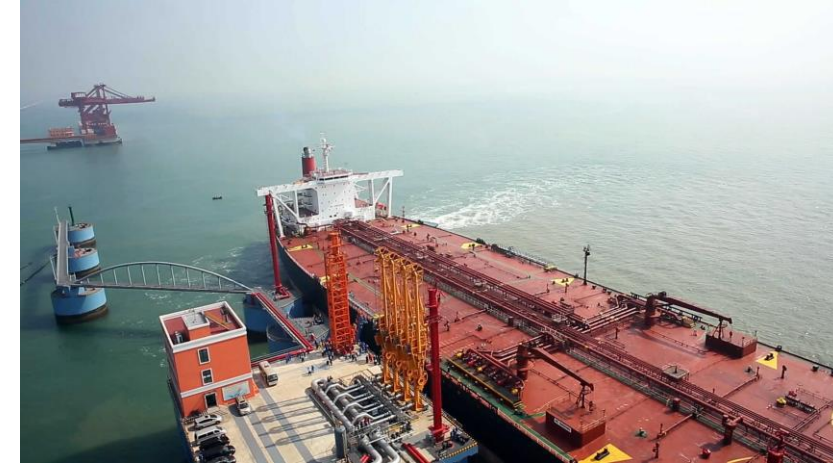
Fact: *A 99K DWT tanker vessel was presented for inspection upon completion of its first foot loading of a cargo of gasoline*

- Joint sampling conducted by Shippers and charterers surveyors, and subsequent testing, showed the cargo loaded to be off specs. (Failed flash point parameters)
- The vessel shifted to anchorage, pursuant to which the vessels owners IG P&I club requested us to attend.

- Attended the lab for testing of these samples together with other interests. (upon witnessing first foot sample extraction)
- We discovered, post testing that Gasoil in all the nominated tanks 1P&S, 4P&S, Slop P&S was Off Specification (as the minimum flash point requirement was 60 degree Celsius.)
- The shore tank sample was jointly tested by us for flash point, and it was observed passed (flash point very close to the minimum required).
- This presented a unusual problem for the owners, since the supplier cargo was in specs.

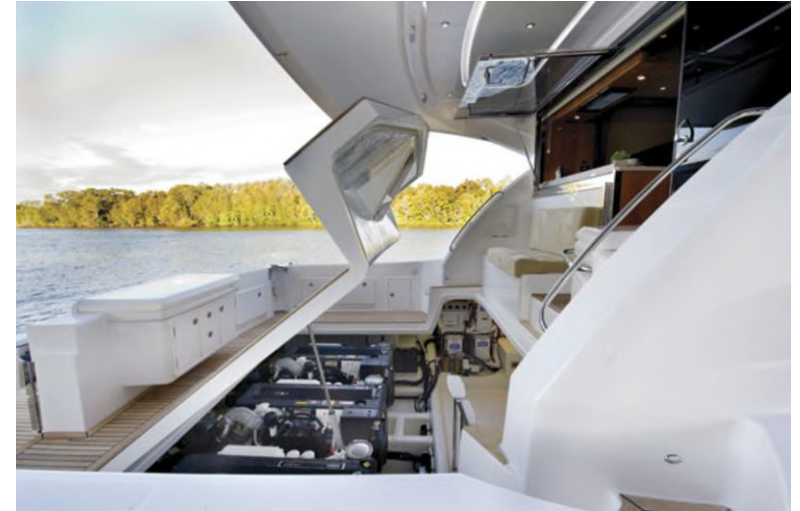
- The engine was already in a dismantled condition at the time of survey. (2 hours turn around post nomination)
- There was an appearance of a whitish colours to the remnants of the lube oil present in the engine casing.
- Investigation revealed that there was a hole in the gasket.
- Further investigation revealed that there were burn marks on the cylinder head.

- We were to put evidence that the cause of engine seizure was due to following tell-tale factors :
 1. There are burnt marks on the cylinder head.
 2. There was a hole in the cylinder head gasket caused by overheating.

3. As a result of hole in the gasket the cooling water mixed with lubricant oil affecting its lubricity, causing the engine to seize.
- A mere act of propeller getting entangled in a HARD rope (rope is not normally hard) would have stopped the engine (but not caused seizing of the engine). In depth knowledge & deeper investigation of facts and tell tails payed its rewards.

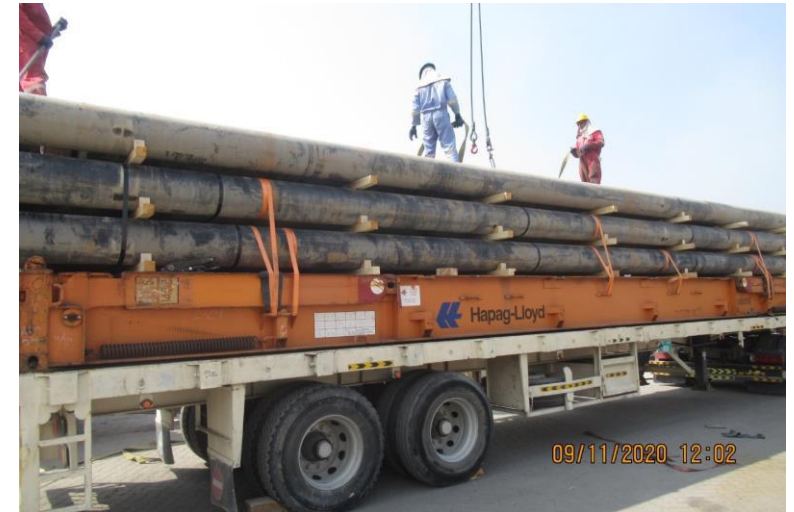
Fact: *The shipper intended to secure feet long pipe casing on multiple 40 feet flat rack as per the international safe practice .*

- Naval Architects prepared sketch for the cargo arrangement on flat rack container as per CSS and CTU Guideline.
- Collaborated with lashing team for full loop and Olympic loop lashing.
- Supervise each tier lashing. (clarifying important distinction)
- Supervised & certified securing of pipes casing on flat-rack container. (Taking to the account vessels GM)

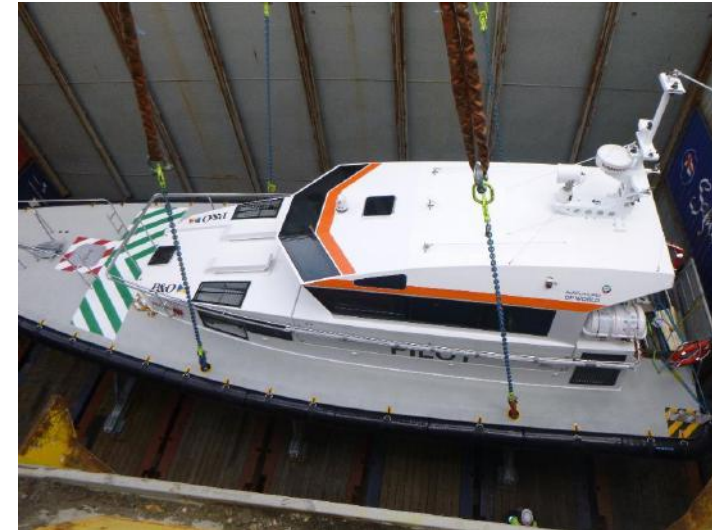
Fact: Boat provided afloat & specs with vessel's GM & location planning given

- We reviewed the lifting plan proposed by the port by calculating the loads with reference to SWL.
- We developed the lashing plan as per the IMO Annex 13, CSS Code.
- Pre-load condition of the cargo was recorded and documented.
- Master Mariner surveyed the safe lifting loading and securing of the cargo on the carrier as per the Method Statement drawn out by us and accepted.

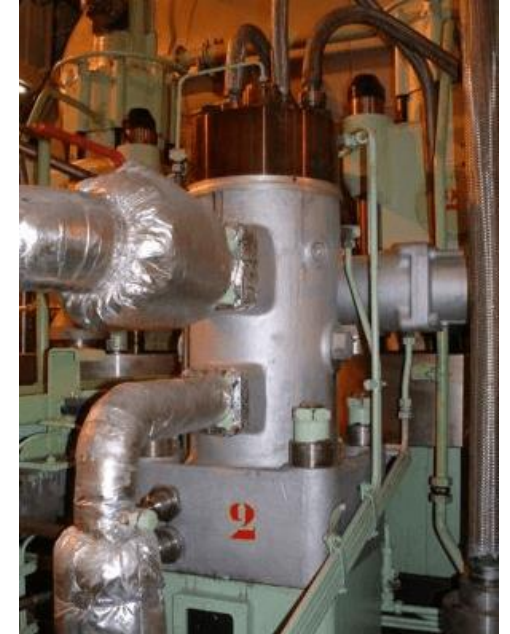
Fact: 12 Nos. plunger and barrels of the fuel pump of the Auxiliary engines belonging to a ship had seized. 8 Nos plunger and barrels of the fuel pump of the Main engine had also seized. There was sludging of the fuel evident.

- The plunger and barrels of fuel pumps of both Main engines and Auxiliary engines were worn out and sticking. The chrome polish on the plunger had vanished.

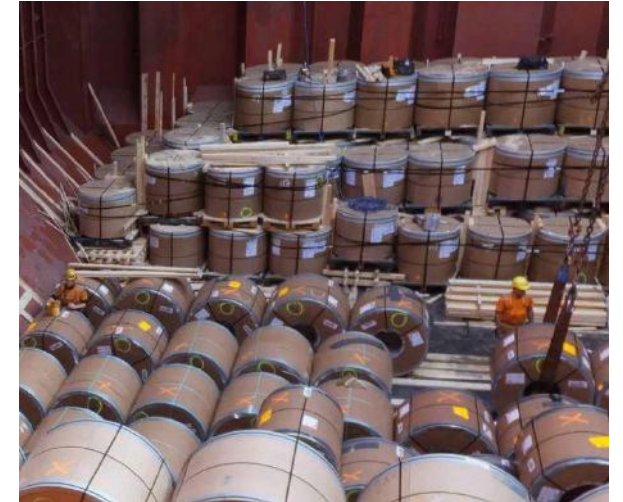
Fact : *Surveyor was nominated to attend a joint survey to investigate cargo appearing in rusty condition.*

- The attending surveyor had checked the shipping marks stipulated on the cargo with the packing list and Bill of Lading. (Which indicated clean cargo – free of rust).
- Silver Nitrate test was carried out at 10% random basis on the rust affected cargo and was found that there was no salinity on the cargo. Further investigated on this matter and it was proven that few days ago there was heavy rain fall (As per the weather reports), and all the cargo which they stored in their open yard and was completely affected by the water rain.

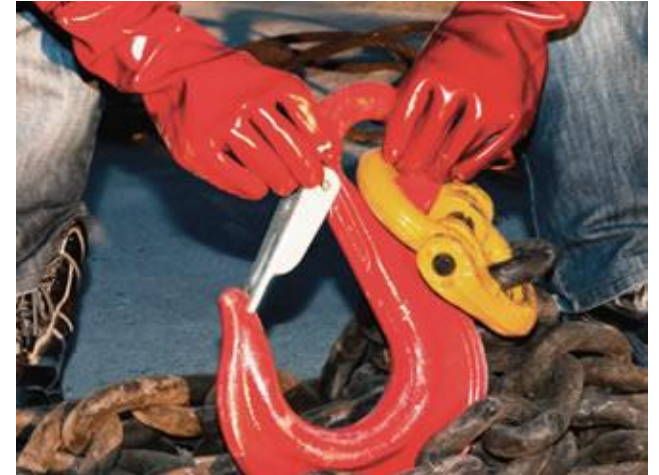
- Condition inspection of each gears with identification marks.
- Checking of operating condition of each gears
- Inspection of load test certificate
- Bridle wire of the barge was seen rusted with lack of greasing (effected immediately)
- Strands of steel was broken which could have reduced the actual SWL of the wire
- The damaged wire was replaced with new spare wire

- The broken strands bridle wire if not replaced it would have parted during the loaded tow voyage and , may have damaged own and other vessel or ports property resulting in avoidable claims.
- If the loose gear was inspected timely the spread, could be rejected for towing and delay charges from port would become to the owners /account
